<p>Letecká 255 686 04 Kunovice Czech Republic</p> <p>Tel.:+420 773 984 338 <a href="mailto:info@brmaero.com">info@brmaero.com</a> <a href="http://www.brmaero.com">www.brmaero.com</a></p>	<b>BULLETIN TITLE: NOSE WHEEL STEERING INSPECTION</b> <b>CLASSIFICATION: MANDATORY SERVICE BULLETIN SAFETY DIRECTIVE/ALERT</b>		
	<b>BULLETIN NUMBER: ALL-SB-0-0-0-ALL-0004-2025</b>		
	Date of issue: 17.07.2024	Revision no.: 0, 1 <sup>st</sup> Issue	Page: 1
	Date of effect: 17.07.2024	Date of rev.: -	Pages: 5

BULLETIN TITLE: <b>NOSE WHEEL STEERING INSPECTION</b>		
CLASSIFICATION: <b>MANDATORY SERVICE BULLETIN SAFETY DIRECTIVE/ALERT</b>		
BULLETIN NUMBER: <b>ALL-SB-0-0-0-ALL-0004-2025</b>		
Date of issue: 17.07.2024	Revision no.: 0, 1 <sup>st</sup> Issue	Page: 5
Date of effect: 17.07.2024	Date of rev.: -	Pages: 5

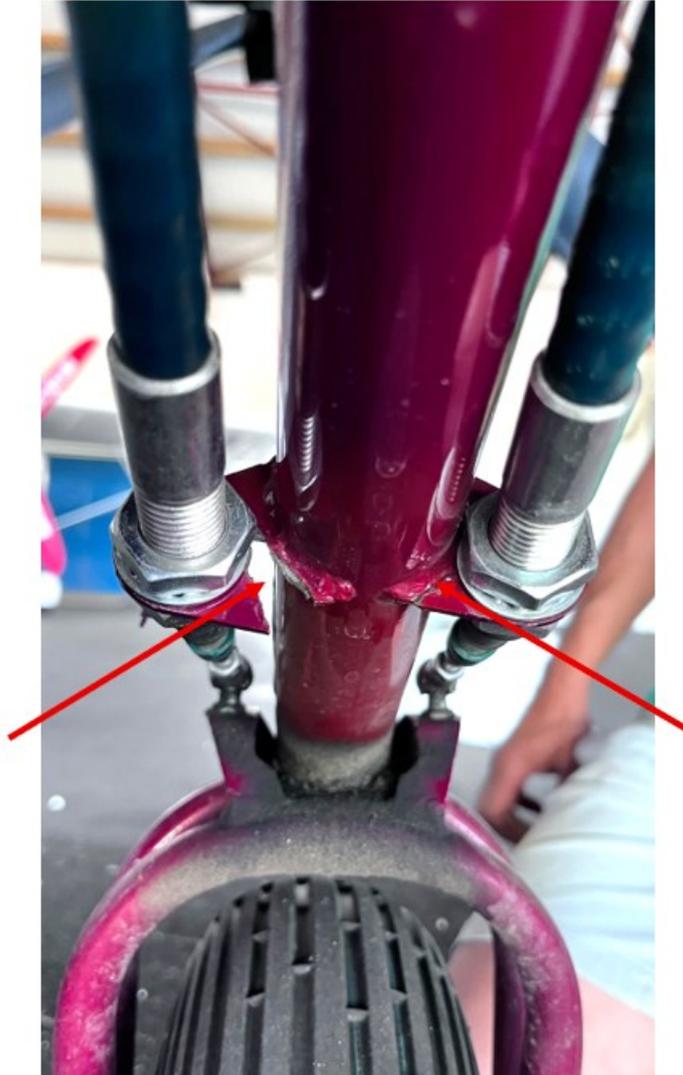
According to information from the German Aeroclub (DAEC), there have been several occurrences of damage to the nose gear steering in the area of the teleflex (push-pull flexible rod) attachment in Bristell aircraft operation – see Figure 1.

This can lead to a reduction or loss of directional controllability of the aircraft on the ground.

The probable cause of damage to the steering is not the flight loads but the ground loads that result when full rudder pedals deflections are applied up to the stops on ground when the aircraft is not in motion. Also ground handling loads caused by the towing bar when the nose wheel is excessively deflected when the aircraft is not yet moving.

Figure 1 Front landing gear leg with broken teleflex brackets

2. **Repair** of the nose gear steering if damage is found. The repair consists in welding the brackets and additional reinforcement see Figure 3.

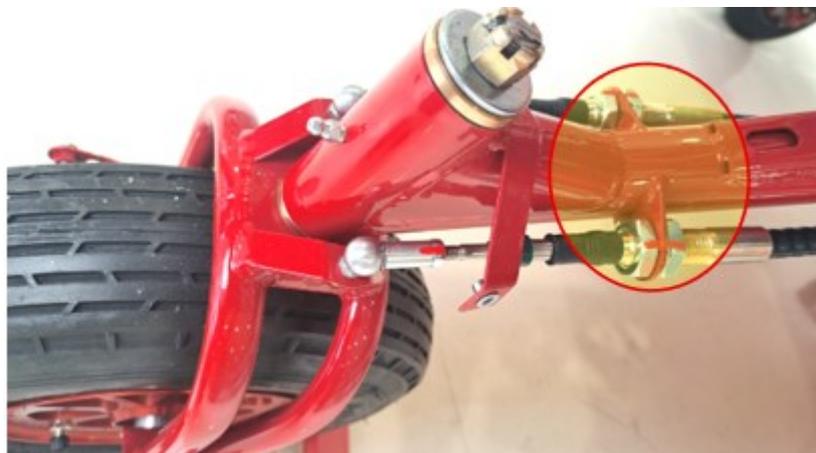
1. **Visual inspection** of the nose landing gear steering with a focus on possible damage (cracks, bends) in the lower area of the teleflex attachment, see Figure 2.

Figure 2 Area to be visually inspected

1. Remove the front landing gear leg cover and front wheel cover.
2. Clean the leg and steering of any dirt.
3. Visually inspect the teleflex mounting brackets, see Figure 2. There must be no cracks in the welds. The brackets must not be bent.  
Note: Also refer to bulletin ALL-SB-0-0-0-ALL-0003-2025 Front Undercarriage Inspection.

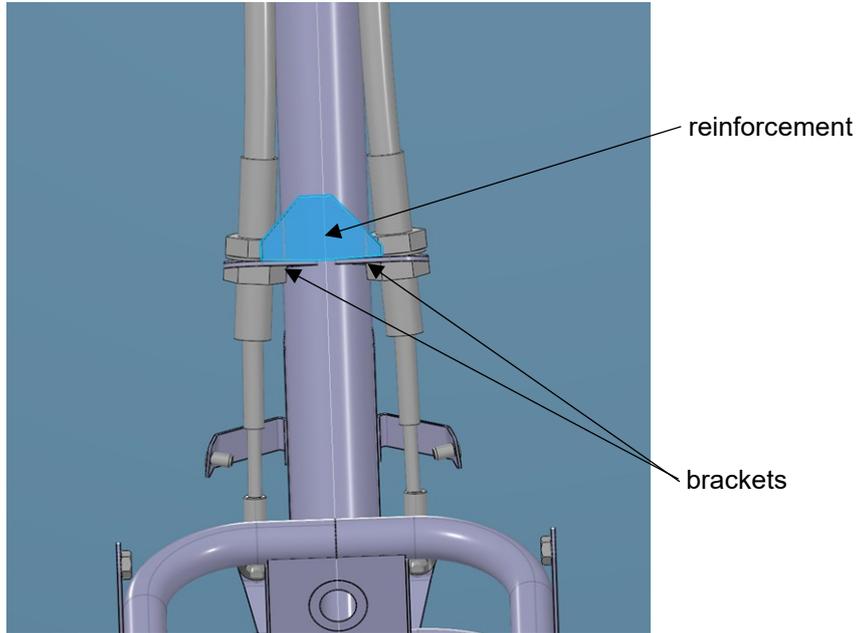
Figure 3 Reinforcement from leg bottom side
